HASLERRail AG Bern

Test for an improved speed sensor for railway ETCS application

Test on SBB vehicles ICBT, RE460; Test on ÖBB vehicle in collaboration with Alstom Transportation; Test on IC1 DB in collaboration with Siemens

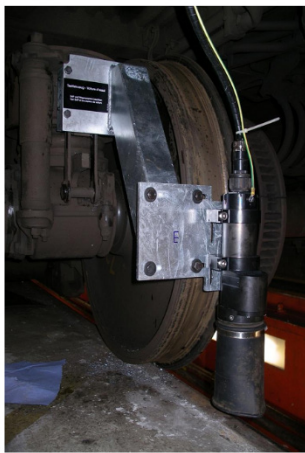
Figure 1. CORRail 1000 Sensor mounted on train

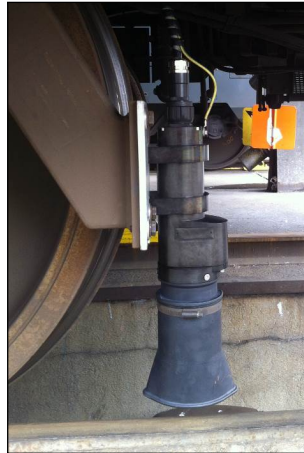
Figure 2. CORRail 1000

One of the most critical factors for such a sensor is to prevent dirt and dust accumulation in the optical path.

The most critical part is the front glass. It must be totally protected.

A specially developed aerodynamic splash guard and a protection tube protect the sensor against such environmental effects.

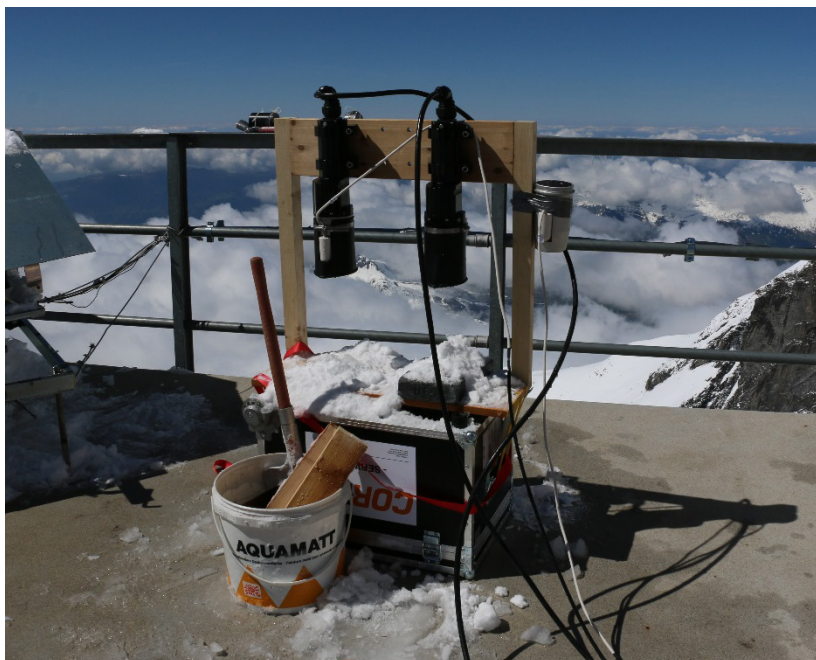
Figure 3. Test set-up.

We mounted two sensors on a rack outside on a platform on the Sphinx terrace. One sensor was equipped with a splash guard and winter kit, the other without winter kit. The winter kit does include, among other things, an electrical heater inside the protection tube, controlled by a thermostat. We used different heater models with variable heating power.

Both sensors were stuffed with snow and the time until the sensors recovered was measured.

We could prove the positive impact of the winter kit, the time for recovering was much shorter.

Within 1 to 4 Minutes the system recovered, depending on the quantity of snow we stuffed in the protection tube and how much it was compressed.
