# Flask comparison on Jungfrauoch

## 1. Project description

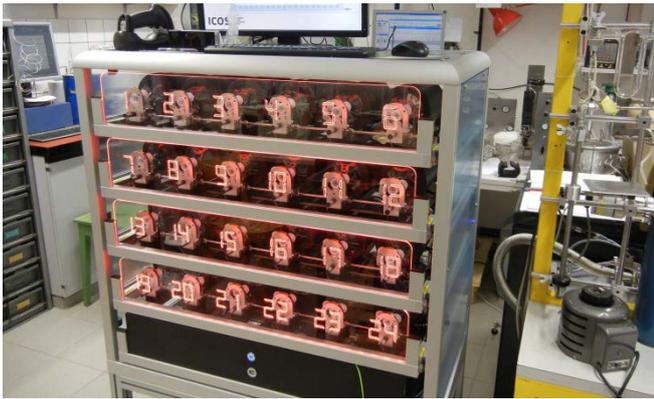
Figure 4. Autosampler for the ICOS-Station Jungfrauoch.

Since 2018 Jungfrauoch is an official ICOS station and requires an ICOS flask sampling unit. UBern purchased such a unit but unfortunately up to now no sampling at Jungfrauoch could be performed. Several issues led to this delay: (i) the autosampler unit itself showed shortcomings when we first received it from the ICOS partner at Jena, this has been resolved by now; (ii) the flasks were delivered with long delay due to problems with the valve settings; and (iii) the flasks were then leak-tested in-house and later-on with a test-unit sent to us from Jena. This led to the conclusion that about 75% of the flasks had problems. Therefore, all flasks were brought back to the company that produced the flasks, where they are at present. As soon as we will have them back we will start with further tests at Bern and once they are in line with the ICOS requirements we will install the autosampler at Jungfrauoch. The space is already allocated.

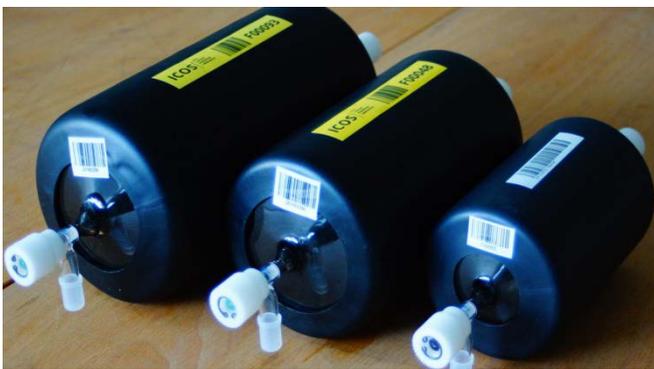
Figure 5. ICOS flask types of 1, 2 and 3 liters.

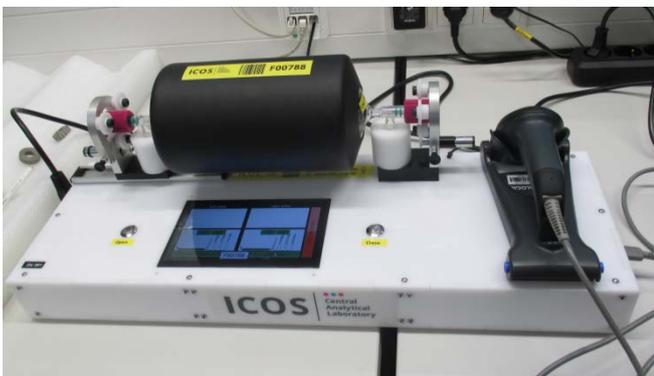
Figure 6. ICOS flask valve test-unit.
